# COMBINED PRELIMINARY ASSESSMENT/SITE INSPECTION REPORT

Camdenton Sludge Disposal Area Site  
Camden County, Missouri

March 30, 1999

Missouri Department of Natural Resources  
Division of Environmental Quality  
Hazardous Waste Program

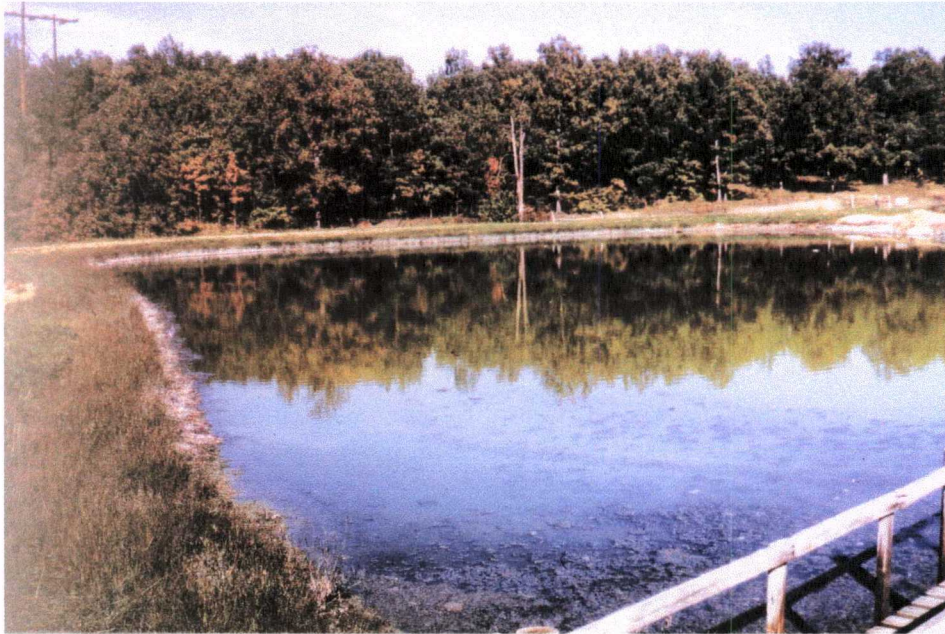
**PHOTO 1**

Former Hulett Lagoon Site. Camdenton, MO, Camden County. Photo taken on 10/1/74 by Ronnie Testerman, MDNR, JCRO. View looking northeast at the Hulett lagoon during operation. The northern portion of the lagoon shown in the photo was where influent from domestic sewage entered the lagoon. A small amount of the sludge from the Sundstrand influent, which came in on the south portion of the lagoon can be seen in the foreground of the photo near the wooden catwalk.

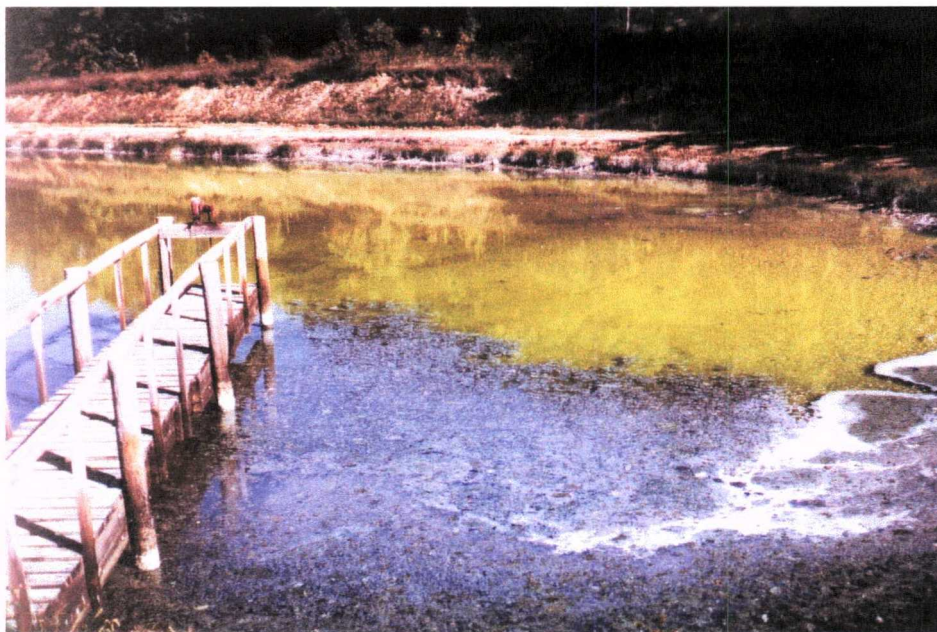
**PHOTO 2**

Former Hulett Lagoon Site. Camdenton, MO, Camden County. Photo taken on 10/1/74 by Ronnie Testerman, MDNR, JCRO. View looking east at the Hulett lagoon during operation. The picture was taken to show the sludge settling around the influent pipe area from Sundstrand.

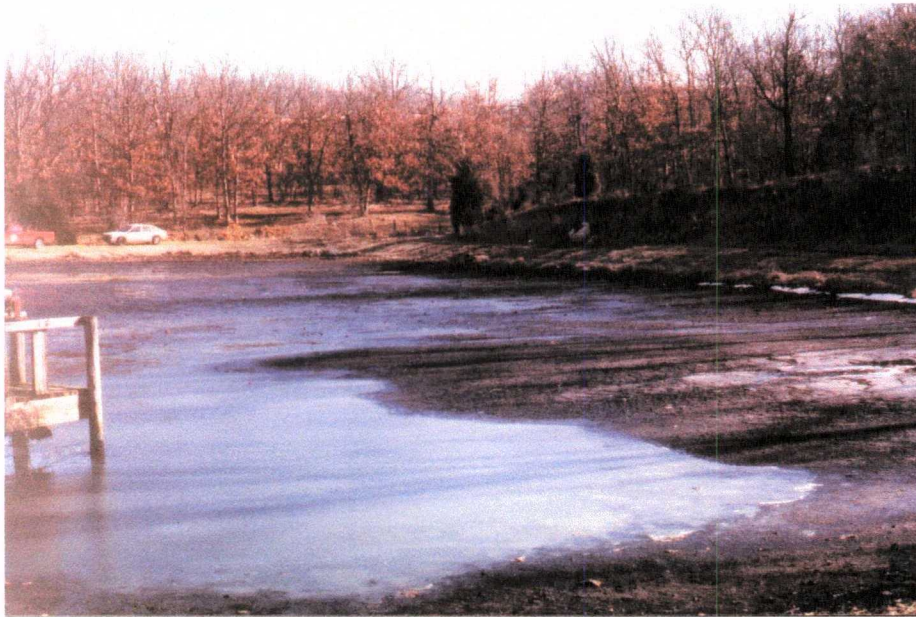
**PHOTO 3**

The following description of the Hulett lagoon is included to provide pertinent background information. The former Hulett lagoon is a closed wastewater sewage lagoon that was operated by the City of Camdenton from 1961 to 1988. The lagoon was approximately one acre in size, located in the City of Camdenton, northeast of the intersection of Dawson Road and Sunset Drive. Photos 1 and 2 were taken in October 1974 when the lagoon was operating. Photo 1 shows the north side of the lagoon where an influent pipe from a city sewer line entered the lagoon. Photo 2 shows the south side of the lagoon where an influent pipe from an industrial facility entered the lagoon. A great deal of sludge settling around the influent is visible. In 1989, the lagoon was closed; the water was drained and the sludge was removed (Reference 9, p. 12). Photo 3 was taken during the dewatering process.

Former Hulett Lagoon Site. Camdenton, MO, Camden County. Photo taken sometime in June or July 1989 by Ronnie Testerman, MDNR, JCRO. View looking northeast at the Hulett lagoon during the beginning of the closure process. The dewatering had begun, but no sludge had been removed.

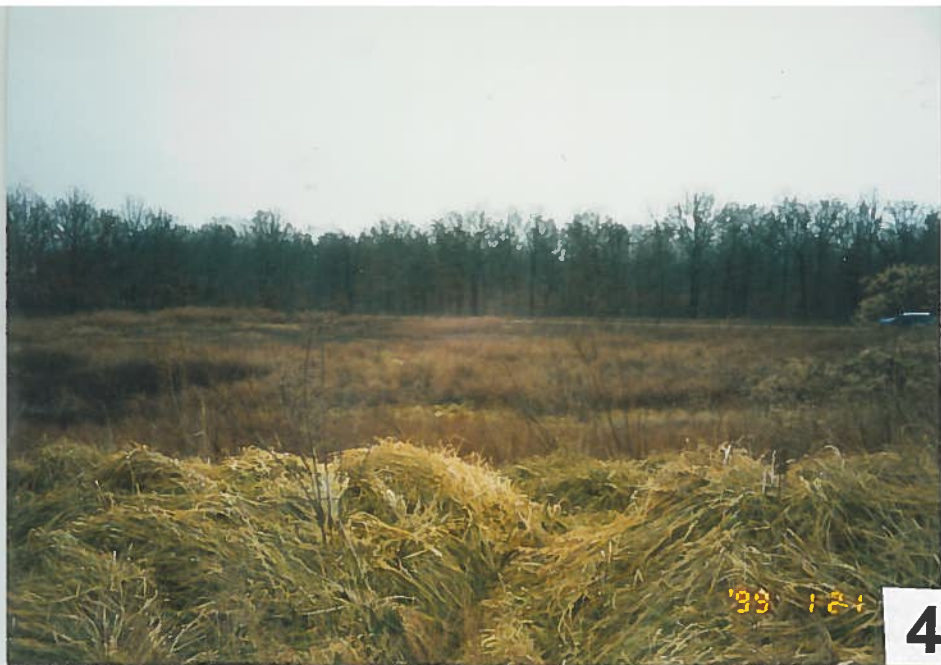
Camdenton Sludge Disposal Area Site. Camden County, MO.  
Photo taken on 1/21/99 by Valerie Wilder, Superfund, MDNR.  
Photo taken looking west <sup>at the</sup> western portion of Field #2 just  
southeast of the Camdenton Memorial Airport runway.

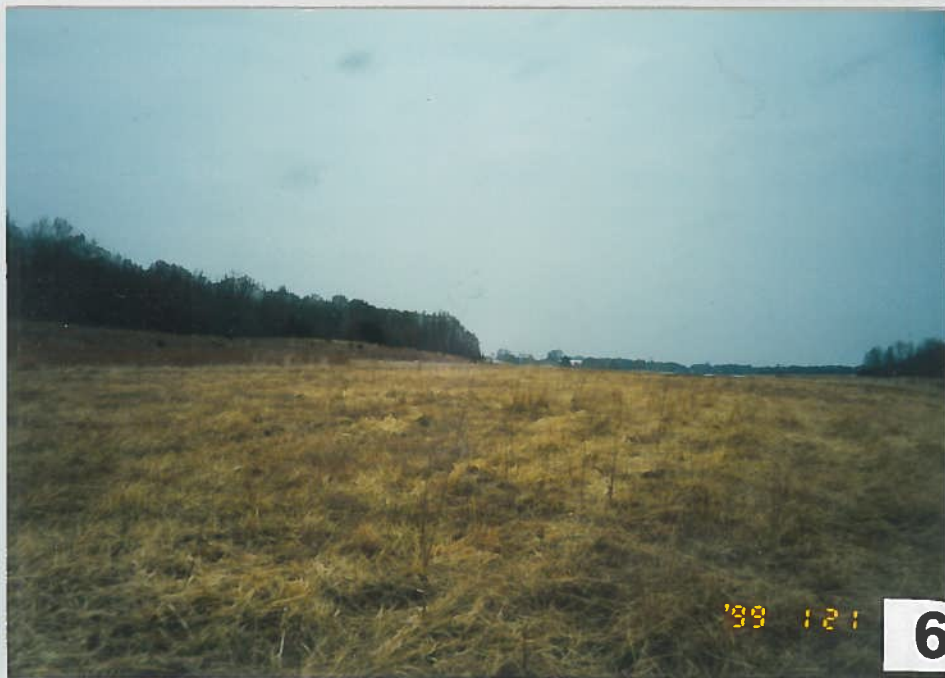
Camdenton Sludge Disposal Area Site. Camden County, MC  
Photo taken on 1/21/99 by Valerie Wilder, Superfund, MDNR.  
Photo taken looking northwest at the northwestern portion of  
Field #2 located just southeast of the Camdenton Memorial  
Airport runway.

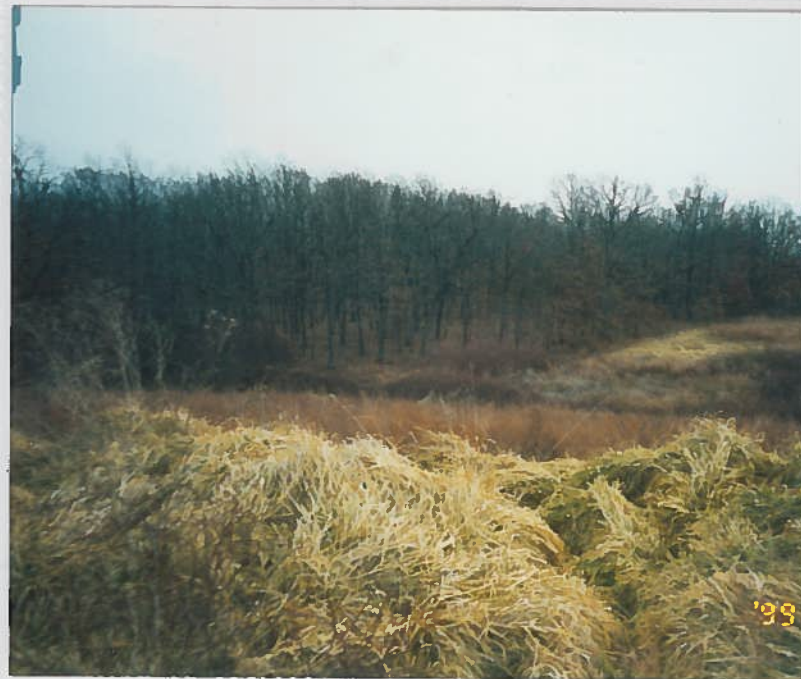
8

Camdenton Sludge Disposal Area Site. Camden County, MO  
Photo taken on 1/21/99 by Valerie Wilder, Superfund, MDNR.  
Photo taken looking southeast at the eastern portion of Field  
#2. The low ditch area that receives most of the drainage from  
the site can be seen in the middle of the photo.
